GRANITE DETERIORATION IN THE GRAVEYARD OF SAINT JAMES THE LESS, PHILADELPHIA

Kathryn Marit Sather

A THESIS

The Graduate Program in Historic Preservation

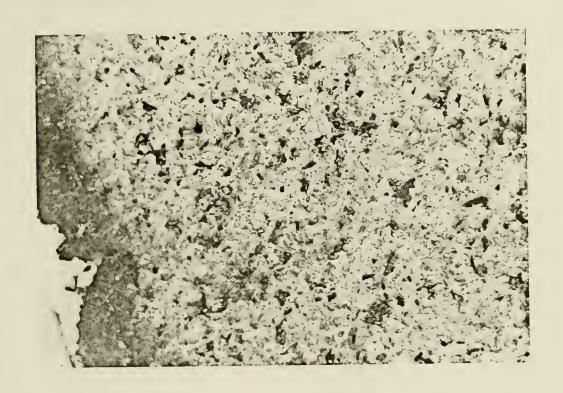
ILLUSTRATIONS 5 & 6
DISCOLORED AREAS ALONG EDGES OF POLISHED SURFACES

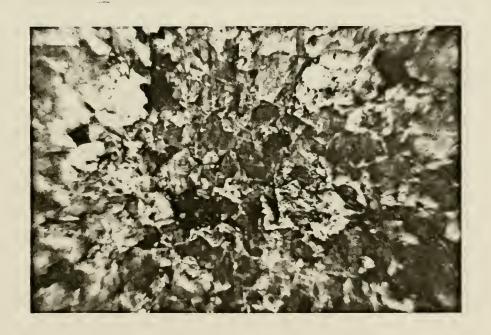
ILLUSTRATIONS 13 & 14 BIOLOGICAL GROWTHS UNDER PROTRUDED AND CHIPPED AREA

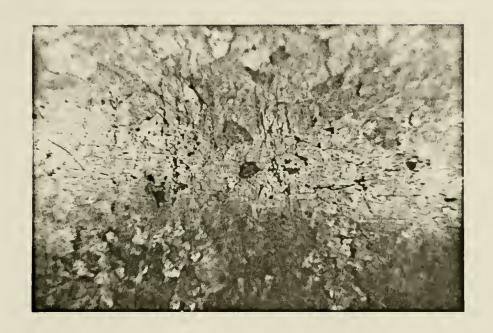
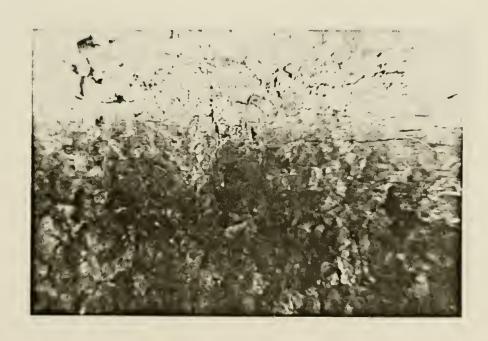
ILLUSTRATIONS 17 & 18 SURFACE PITTING WITH CLAY PRESENT

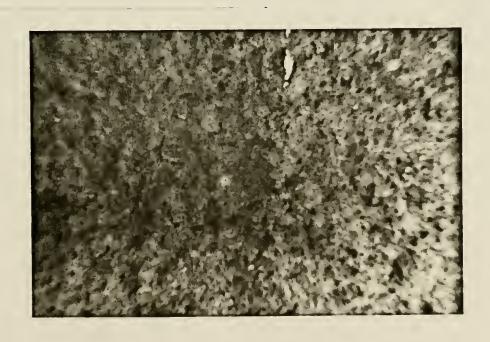
ILLUSTRATIONS 19 & 20 SURFACE PITTING WITH CLAY PRESENT

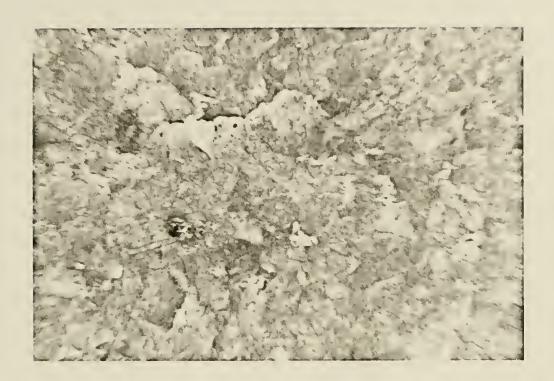
ILLUSTRATION 21
SURFACE PITTING WITH CLAY PRESENT
